Manhole Inspection Summary

Manhole # S43II_051MH

Insp Date: **7/2/09 8:42 AM**

Location Address: **INTER FEDERAL ST**

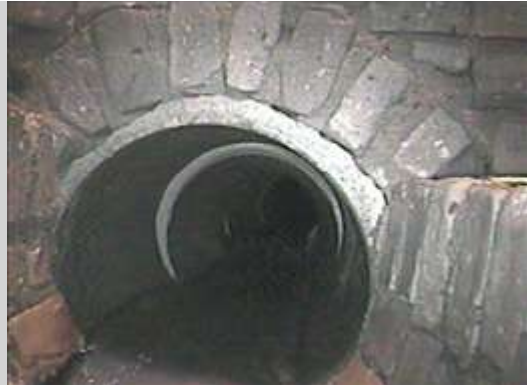
12 O'Clock Outflow

Pipe Height: **7.2** (in.) Rod and Bar
Pipe Material: **Clay** ☐ Pipe Lined
Invert Depth: **14.34** (ft.) Flow Characteristics: **Fast**
Deposits: ☒ None ☐ Mud ☐ Sludge ☐ Debris ☐ Grease
Silt Depth: (in.) Deposits Extent:
Infiltration: **None** Pipe Seal Cond: **Sound**

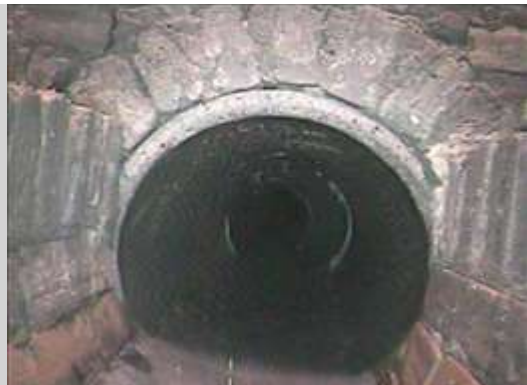
6 O'Clock Inflow

Pipe Height: (in.) Direct
Pipe Material: **Clay** ☐ Pipe Lined
Invert Depth: **14.31** (ft.) Flow Characteristics: **Fast**
Deposits: ☒ None ☐ Mud ☐ Sludge ☐ Debris ☐ Grease
Silt Depth: (in.) Deposits Extent:
Infiltration: **None** Pipe Seal Cond: **Sound**

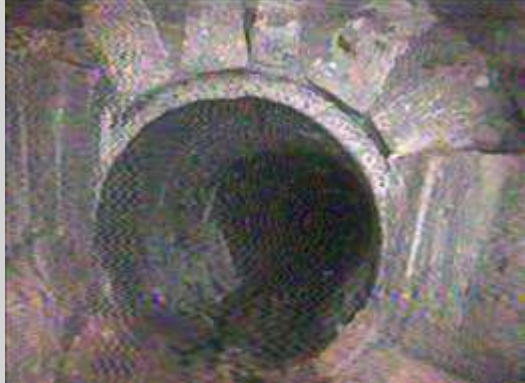
9 O'Clock Inflow

Infiltration: **None** Pipe Seal Cond: **Sound**
